Water Compliance Inspection Report

NPDES WAU 0000599

***NPDES
Inspection Report***

***Marmel Dairy
Everson, WA 98247***

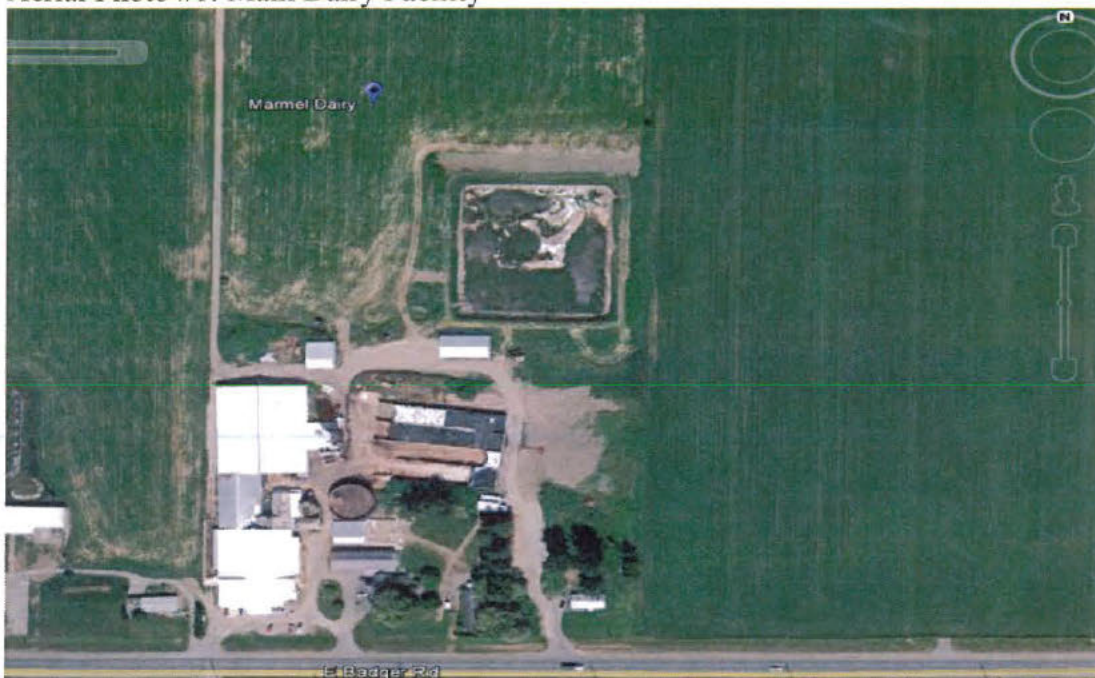
Aerial Photo #1: Main Dairy Facility

Marmel Dairy has confined animals in 3 separate locations. The main facility consists of a barn complex where animals are confined, fed, and maintained. It also includes a milk parlor, a silage storage area, a below ground waste storage tank, a 500,000 gallon above ground storage tank, a waste storage lagoon and adjacent pastures. See Attachment A, Aerial Photo #1.

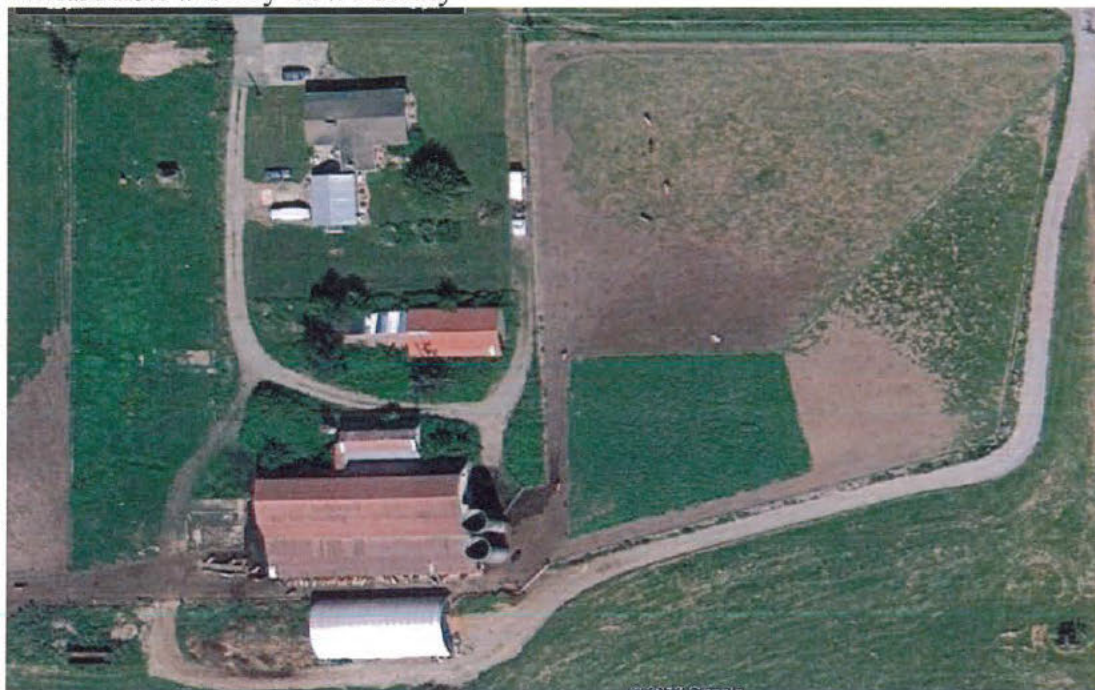
Aerial Photo #2: Dry Cow Facility

The second location is located roughly 500ft to the west of the main facility and on the south end of East Badger Road. This is where the dry cows are confined, fed, and maintained. This dry cow facility contains a below ground waste storage tank and adjacent pastures. See Attachment A, Aerial Photo #2.

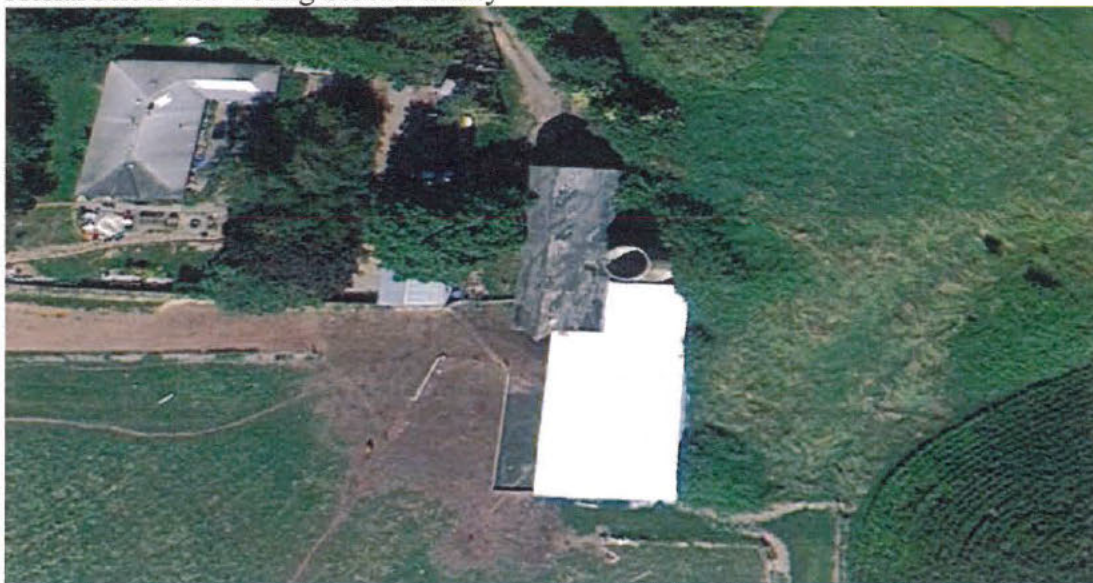
Aerial Photo #3: Young Stock Facility

The third location is a young stock facility referred to as the “north barn” which is located a mile north of the main facility. This facility consists of a barn complex where animals are confined, fed, and maintained. It also includes a small manure pit and adjacent pastures. See Attachment A, Aerial Photo #3.
